# Manhole Inspection Summary

Manhole # S57EE\_003MH

Insp Date: **6/5/08 10:12 AM**

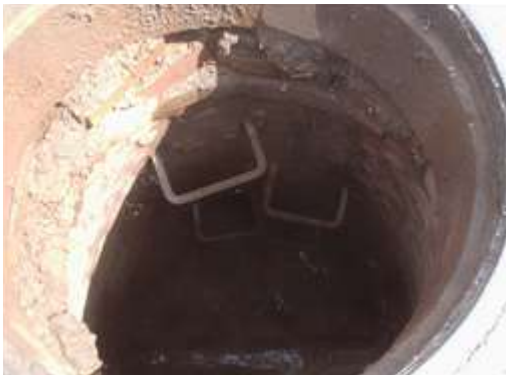
Defect 2

Condition: ☐ Sound ☐ Cracked ☐ Root Intrusion ☒ **Loose Brick** ☐ Deteriorated

Infiltration: ☐ None ☒ **Joint** ☐ Cracks ☒ **Mortar** ☐ Roots ☐ Wall

Loose bricks, Infiltration

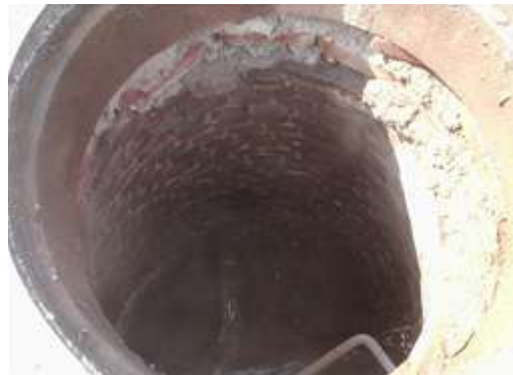
Defect 1

Infiltration mortar joint

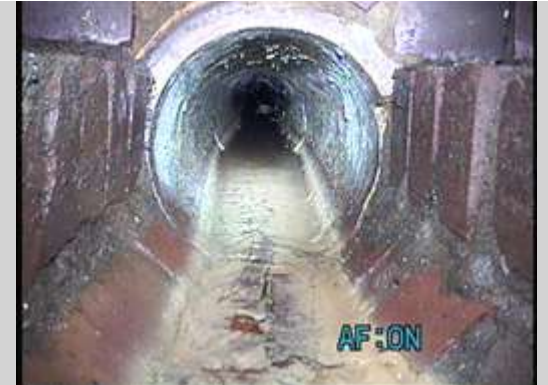
12 O'Clock Outflow

8 in. Circular Gravity Sewer  
Pipe Out @ 12 O'Clock

Pipe Height: **8.4** (in.) Rod and Bar (Angled)  
Pipe Material: **Clay** ☐ Pipe Lined  
Invert Depth: **8.90** (ft.) Flow Characteristics: **Slow**  
Deposits: ☒ None ☐ Mud ☐ Sludge ☐ Debris ☐ Grease  
Silt Depth: (in.) Deposits Extent:  
Infiltration: **None** Pipe Seal Cond: **Sound**

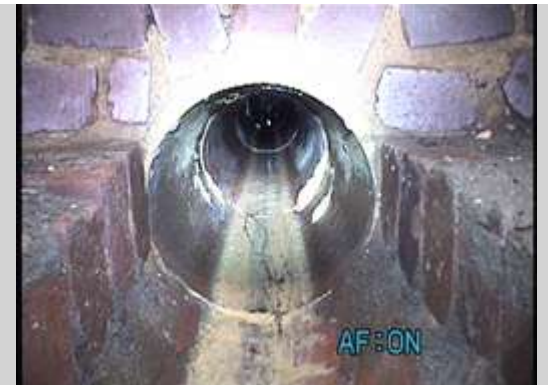
3 O'Clock Inflow

8 in. Circular Gravity Sewer  
Pipe In @ 3 O'Clock

Pipe Height: **8.4** (in.) Rod and Bar (Angled)  
Pipe Material: **Clay** ☐ Pipe Lined  
Invert Depth: **8.70** (ft.) Flow Characteristics: **Slow**  
Deposits: ☒ None ☐ Mud ☐ Sludge ☐ Debris ☐ Grease  
Silt Depth: (in.) Deposits Extent:  
Infiltration: **None** Pipe Seal Cond: **Sound**

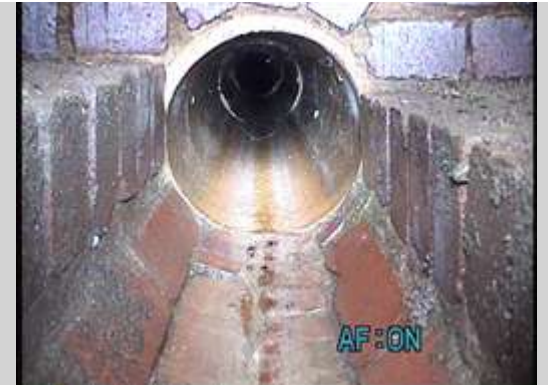
6 O'Clock Inflow

Infiltration: **None** Pipe Seal Cond: **Sound**
